**Flood Control Project Maintenance
Levee Inspections**

Maintenance Issue Types Only, Levee Inspection Report By Mile - Spring 2019

Reclamation District No. 2064 River Junction

| Waterway | Bank | Unit Miles | Inspection Start/End | Inspector |
|---|---|---|---|---|
| Unit No. 01 San Joaquin River | Right | 5.56 | 04/29/2019 04/29/2019 | Alberto De Leon |

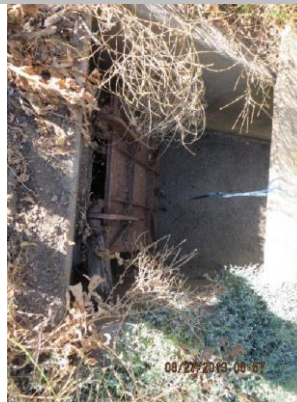
Photo 2 of 3 : UCIP_SP_2019_43603_31257.jpg

| FS_ID:43603 DS_ID:20511 EP_NO: N/A Repair Type: No Action Needed Crossing Status: Found UCIP Comments: Debri removed from flap gate on waterside tow FIELD_STRUCT_DESC: 36-inch by 36-inch reinforced concrete box drainage culvert through the levee, 21 feet below the crown. Concrete U- shaped headwalls on both ends. Slide gate in a 6-foot by 7-foot concrete riser on the waterside (WS) slope. Flap gate on the WS end. Flashboard slots on the landside (LS) headwall. [Additional Reference(s): DWR Levee Log, 2005. USACE San Joaquin O&M Manual 3, December 1968, (HLM 0.07)]. FS Date: 3/2/2015 | | | | | |

Flap gate and U shaped headwall on WS toe. Debris blocking closure of gate.

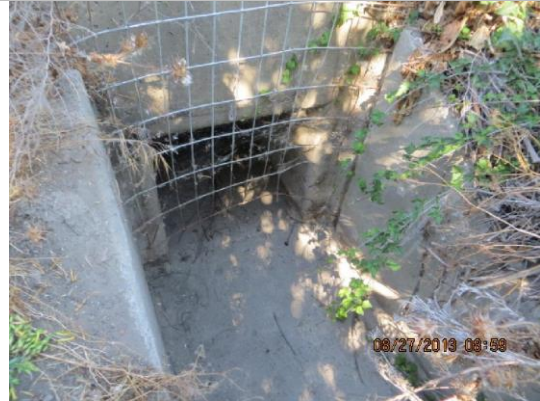
Photo 3 of 3 : UCIP_SP_2019_43603_31256.jpg

Concrete headwall at inlet on LS toe.

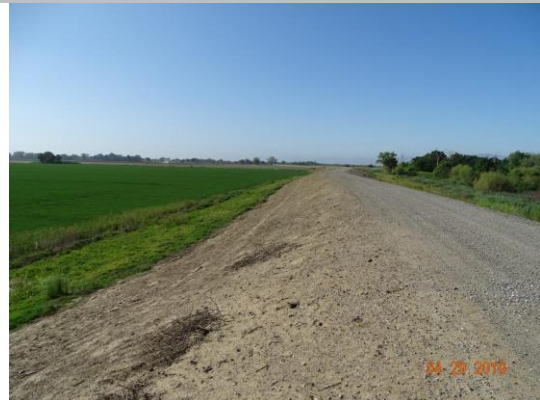
Photo 1 of 1 : SP_2019_RD2064_313_28_20190514_00054.jpg

| Annual vegetation is well maintained. | | | | | |

Typical view of vegetation on landside slope. (Spring 2019)

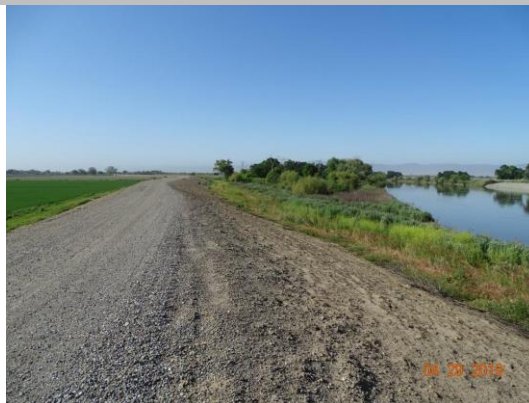
Photo 1 of 1 : SP_2019_RD2064_313_35_20190514_00055.jpg

| Annual vegetation is well maintained. | | | | | |

Typical view of vegetation on waterside slope. (Spring 2019)

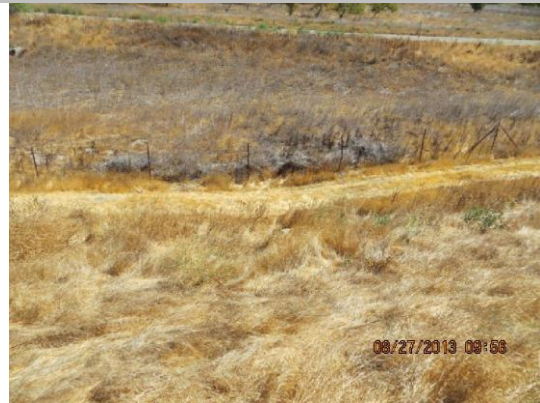
Photo 1 of 3 : UCIP_SP_2019_18748_31380.jpg

Concrete headwall on LS toe.

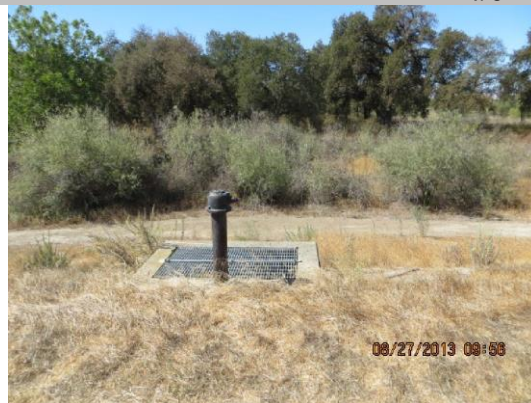
Photo 2 of 3 : UCIP_SP_2019_18748_31379.jpg

Slide gate in concrete vault on WS shoulder.

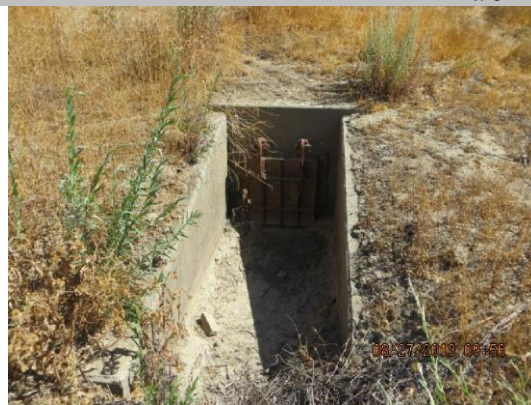
Photo 3 of 3 : UCIP_SP_2019_18748_31378.jpg

Flap gate on WS toe.

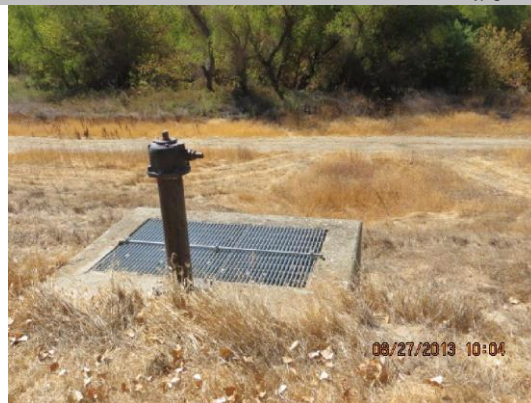
Photo 1 of 3 : UCIP_SP_2019_18763_31402.jpg

| FS_ID:18763 DS_ID:20515 EP_NO: N/A Repair Type: Non-Urgent Crossing Status: Found UCIP Comments: Culvert filled nearly to the top with soil. FIELD_STRUCT_DESC: 30-inch by 30-inch reinforced concrete box drainage culvert through the levee, 14.7 feet below the crown. Slide gate in a concrete riser on the waterside (WS) slope. Concrete U-shaped headwalls on both ends. Flap gate on the WS end. [Additional Reference(s): DWR Levee Log, 2005. USACE San Joaquin O&M Manual 3, December 1968, (HLM 1.93)]. FS Date: 8/27/2013 | | | | | |

Slide gate in Concrete riser on WS shoulder.

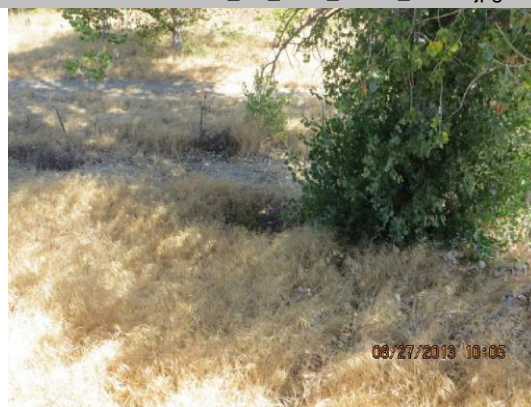
Photo 2 of 3 : UCIP_SP_2019_18763_31401.jpg

Concrete U-shaped headwall on LS toe.

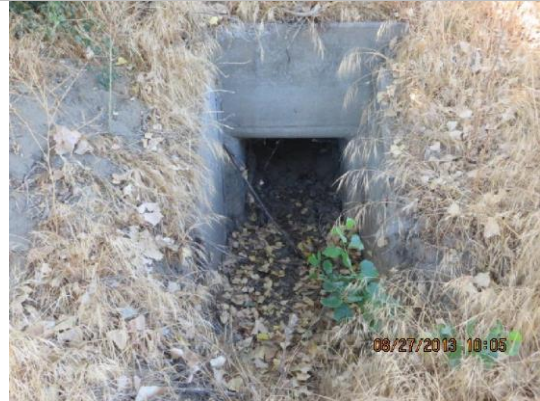
Photo 3 of 3 : UCIP_SP_2019_18763_31400.jpg

Concrete U-shaped headwall on LS toe.

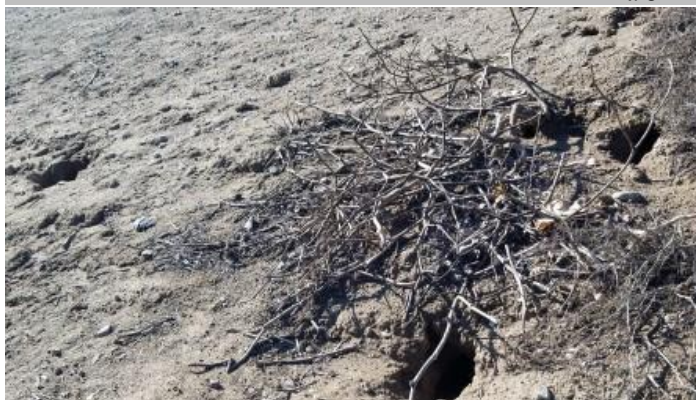
Photo 1 of 1 : SP_2019_RD2064_313_31_20190313_00012.jpg

View of animal holes on levee slope. Fall 2018

| Old rodent holes need to be backfilled. | | | | | |

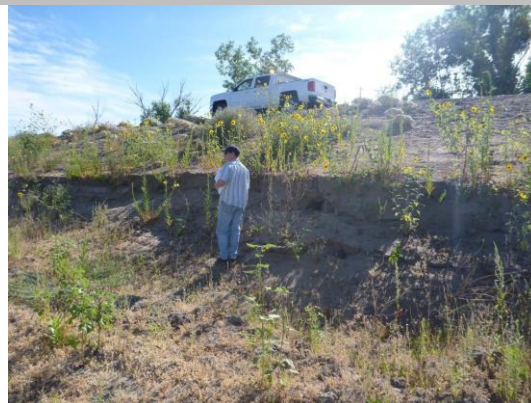
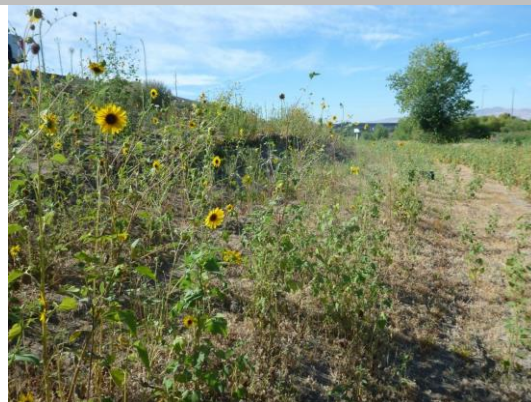
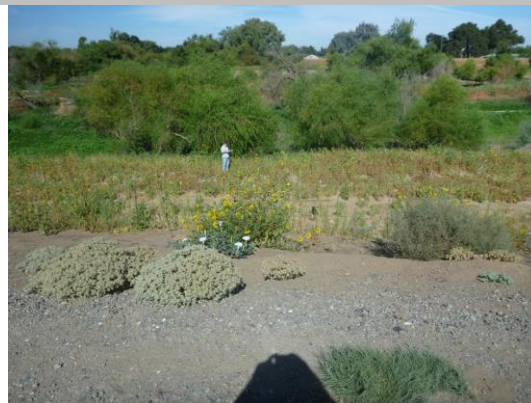
| Description:Erosion from high water flows caused erosion scarps from 12" to 30" in height. The area of damage is approximately 400 feet in length. | | | | | |

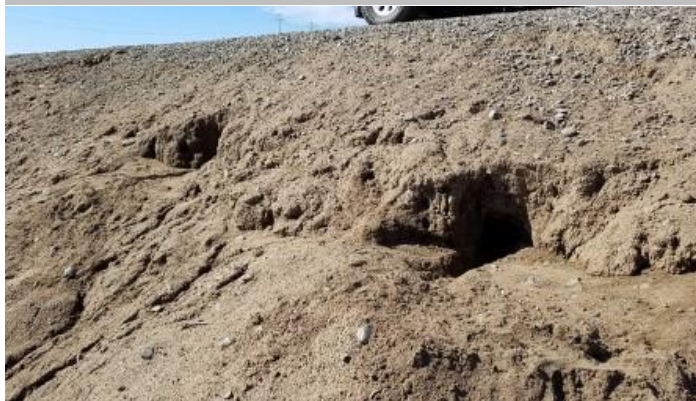
Photo 1 of 2 : SP_2019_RD2064_313_10_20190313_00001.jpg

View of animal holes on levee slope. Fall 2018

| Rodent control program has largely mitigated the problem, but should continue. In addition to the active baiting program, LMA needs to backfill rodent holes. | | | | | |

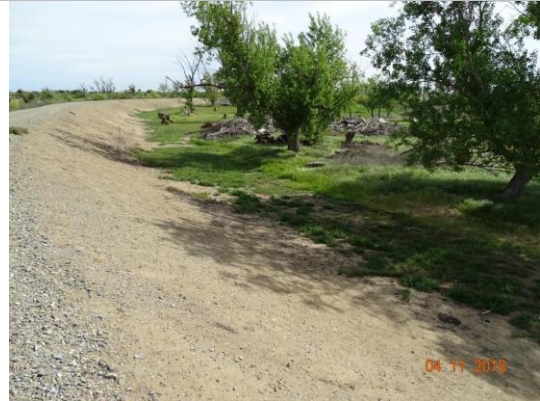
Photo 2 of 2 : SP_2019_RD2064_313_10_20190313_00002.jpg

View of former landside rodent area and slash pile in distance. Fall 2017

| Rodent control program has largely mitigated the problem, but should continue. In addition to the active baiting program, LMA needs to backfill rodent holes. | | | | | | |

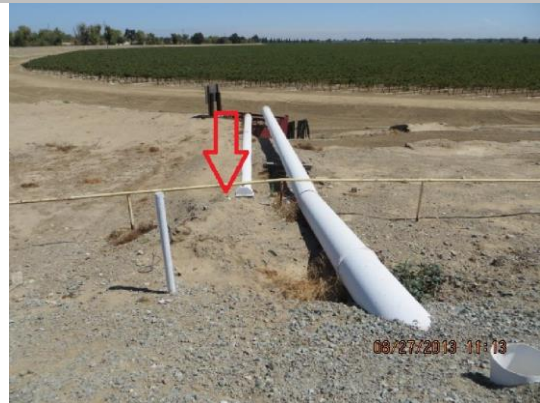
Photo 1 of 2 : UCIP_SP_2019_22732_38465.jpg

| FS_ID:22732 DS_ID:20525 EP_NO: N/A Repair Type: Non-Urgent Crossing Status: Found UCIP Comments: Need to determine if pipe was actually removed from levee. FIELD_STRUCT_DESC: 12-inch steel drainage pipe through the levee, at an unknown depth. Steel plate welded over the landside (LS) end at the LS toe. (Permit No. 6450, 1969 - Reclamation District No. 2064, states it was removed in 1973, but it remains visible on the LS toe). [Additional Reference(s): USACE San Joaquin O&M Manual 3, December 1968, (HLM 3.55)]. FS Date: 8/27/2013 | | | | | |

Pipe visible on LS toe.

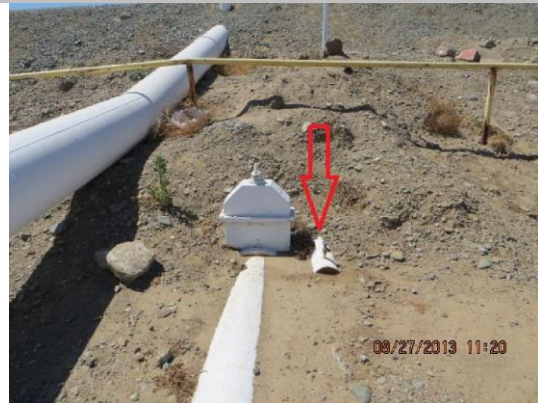
Photo 2 of 2 : UCIP_SP_2019_22732_38464.jpg

Pipe with welded steel plate over LS end at LS toe.

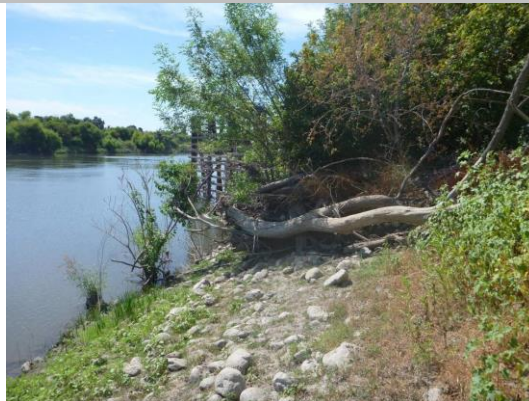
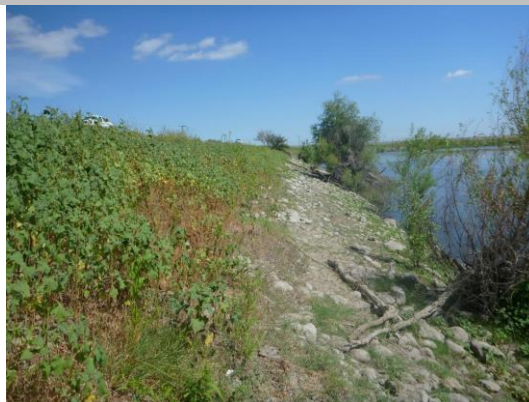
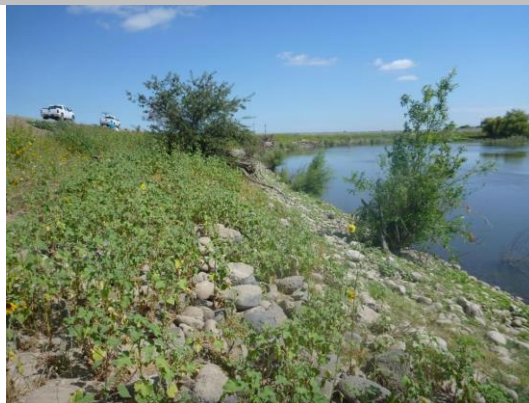
| Description:Erosion from high water flows caused erosion scarps from 12" to 24" in height. The area of damage is approximately 600 feet in length. | | | | | |
| Notes: Minor toe erosion | | | | | |

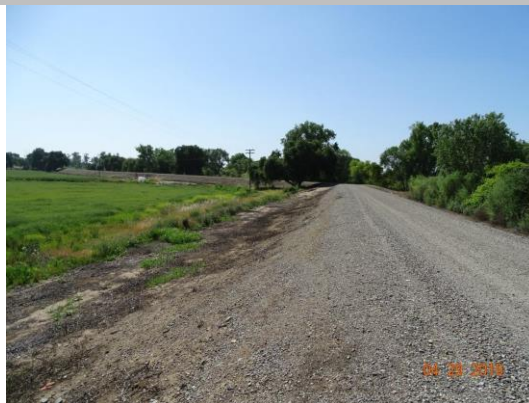
Photo 1 of 1 : SP_2019_RD2064_314_19_20190514_00053.jpg

| Annual vegetation is well maintained. | | | | | |

Typical view of vegetation on landside slope. (Spring 2019)

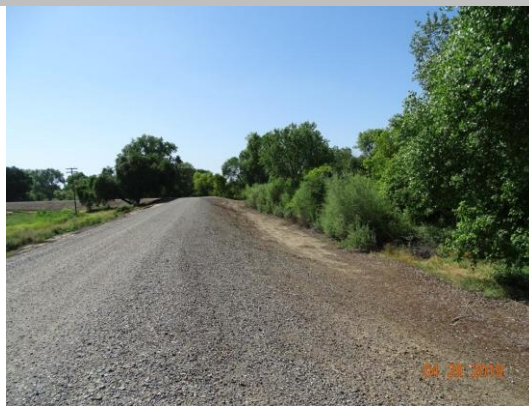
Photo 1 of 1 : SP_2019_RD2064_314_21_20190514_00052.jpg

| Annual vegetation is well maintained. | | | | | |

Typical view of vegetation on waterside slope. (Spring 2019)

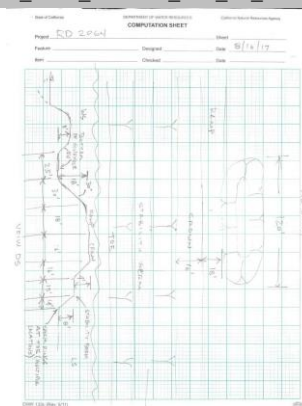
Photo 1 of 1 : SP_2019_RD2064_314_20_20190313_00002.jpg

| Levee Evaluation Comments Description: POI is a waterside sinkhole with an existing seepage berm on the landside. This site was flood fought in 2017 with sack rings. Site ID No: 584 Site Designation: LMA-490 Repair Type: Stability Rating: Area of Concern Field Date: 8/16/2017 Notes: POI is a waterside sinkhole | | | | | |

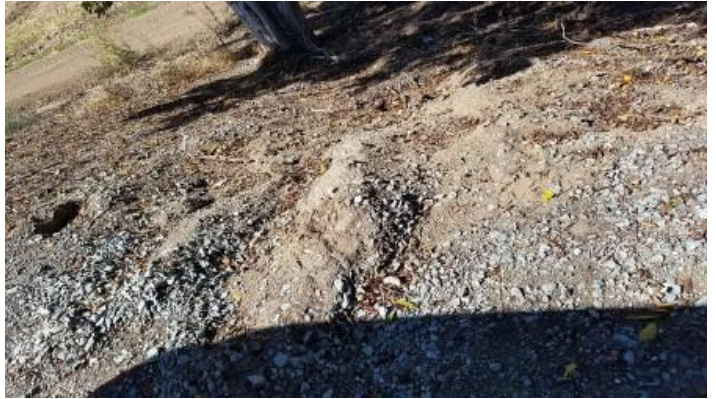
Photo 1 of 1 : SP_2019_RD2064_314_28_20190313_00005.jpg

View of slope damage from vehicular traffic. Fall 2018

| S3 : Repair the levee slope damaged by vehicle traffic and prevent access where possible. | | | | | |
| Slope damage caused by vehicular traffic needs to be repaired. | | | | | |

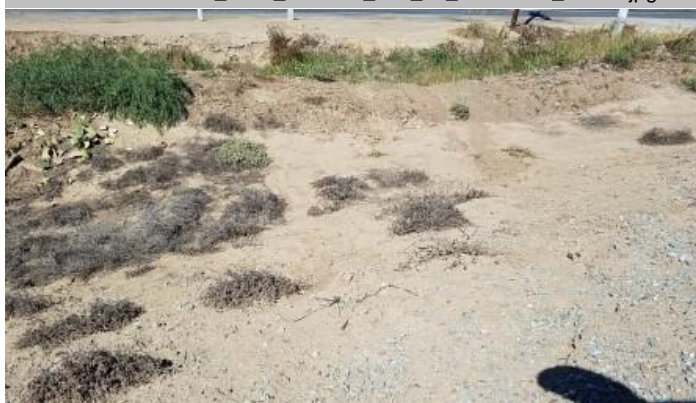
Photo 1 of 1 : SP_2019_RD2064_314_33_20190313_00007.jpg

View of slope damage near ditch caused by vehicular traffic. Fall 2018

| S3 : Repair the levee slope damaged by vehicle traffic and prevent access where possible. | | | | | |
| Monitor vehicle traffic on the levee slope. | | | | | |

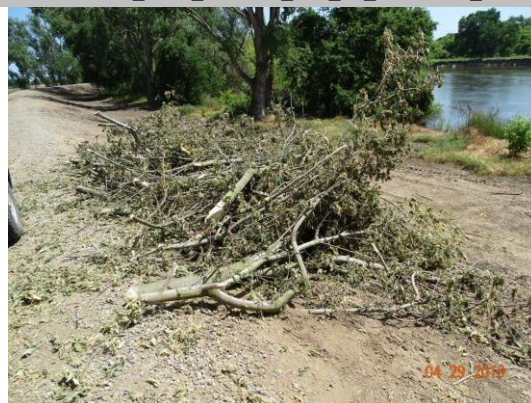
Photo 1 of 1 : SP_2019_RD2064_314_37_20190514_00055.jpg

| There is a pruning pile on the waterside shoulder. | | | | | |

View of pruning pile on waterside shoulder obstructing visibility. (Spring 2019)

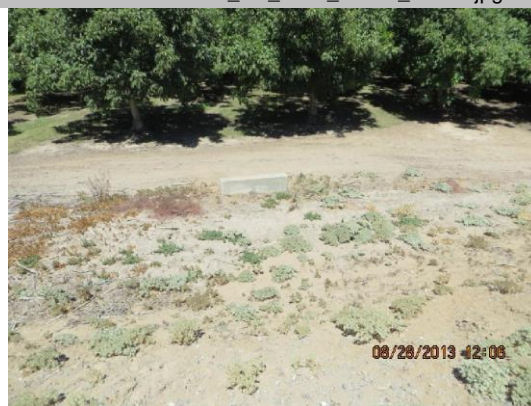
Photo 1 of 3 : UCIP_SP_2019_19117_32069.jpg

Headwall on LS toe.

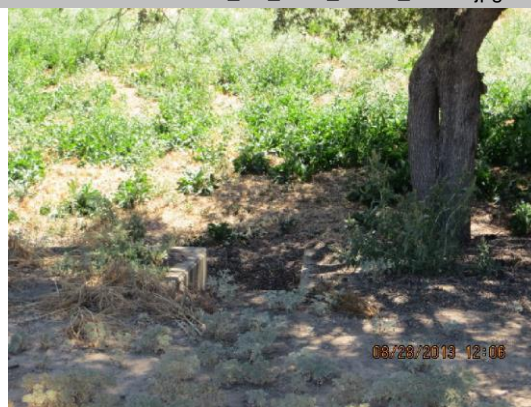
Photo 2 of 3 : UCIP_SP_2019_19117_32068.jpg

Headwall on WS toe.

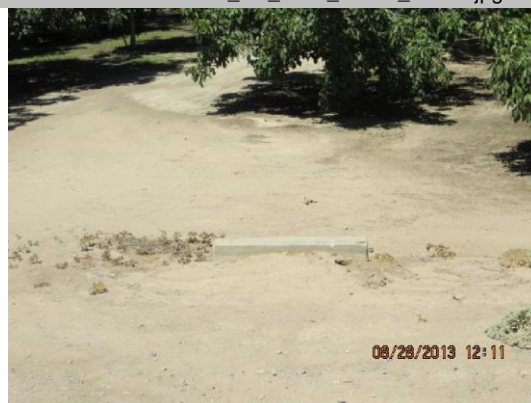
Photo 2 of 3 : UCIP_SP_2019_22793_38841.jpg

Concrete headwall on LS toe.

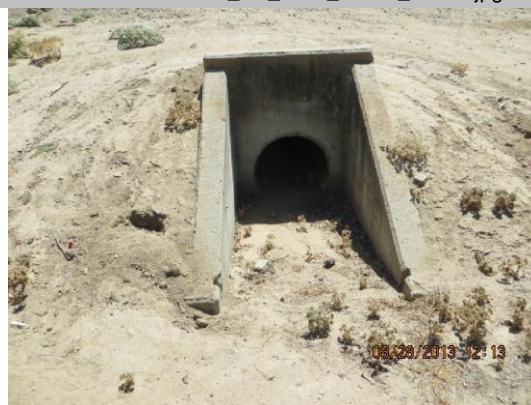
Photo 3 of 3 : UCIP_SP_2019_22793_38844.jpg

Concrete headwall on LS toe.

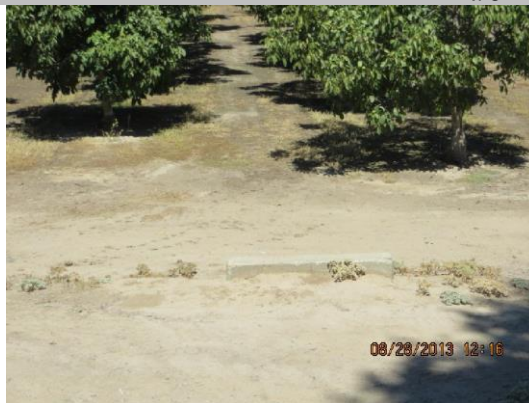
Photo 1 of 3 : UCIP_SP_2019_19120_32079.jpg

Concrete headwall on LS toe.

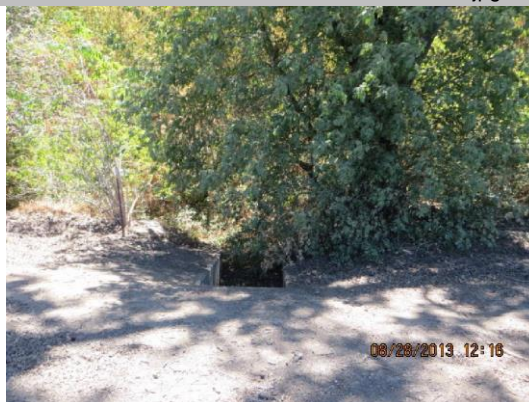
Photo 2 of 3 : UCIP_SP_2019_19120_32078.jpg

Concrete headwall on WS toe.

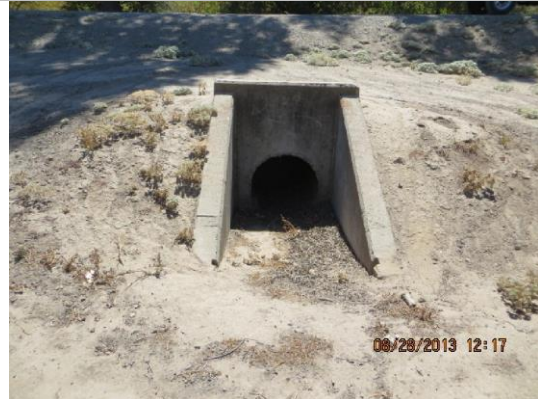
Photo 3 of 3 : UCIP_SP_2019_19120_32077.jpg

Concrete headwall on LS toe.

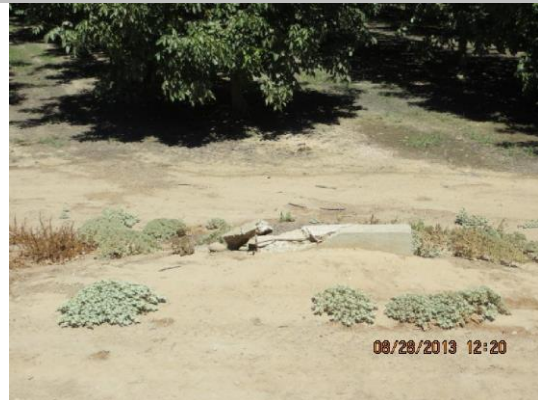
Photo 1 of 3 : UCIP_SP_2019_19122_32083.jpg

Concrete headwall on LS toe.

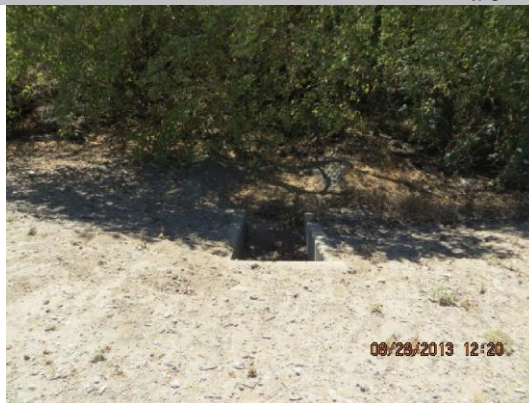
Photo 2 of 3 : UCIP_SP_2019_19122_32082.jpg

Concrete headwall on WS toe.

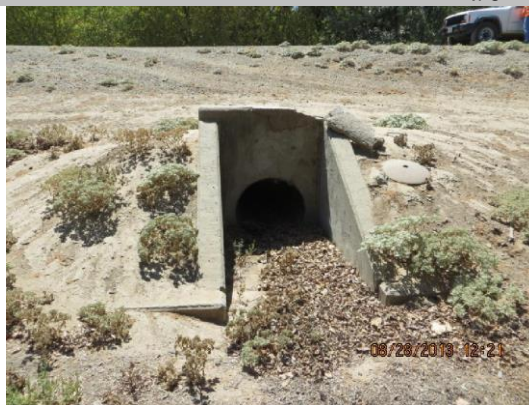
Photo 3 of 3 : UCIP_SP_2019_19122_32081.jpg

Concrete headwall on LS toe.

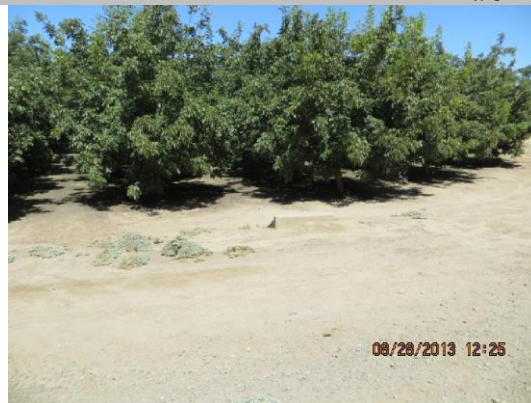
Photo 1 of 3 : UCIP_SP_2019_19143_32122.jpg

Concrete headwall on LS toe.

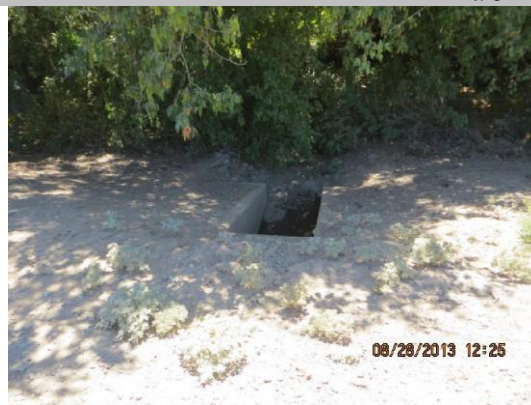
Photo 2 of 3 : UCIP_SP_2019_19143_32121.jpg

Concrete headwall on WS toe.

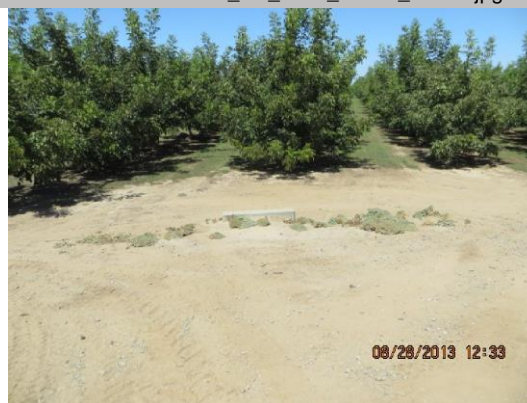
Photo 2 of 3 : UCIP_SP_2019_22794_38850.jpg

Concrete headwall on LS toe.

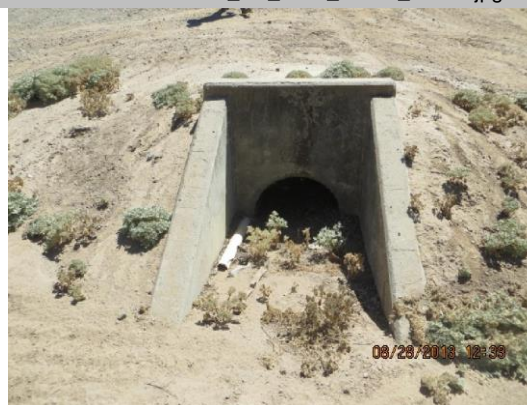
Photo 3 of 3 : UCIP_SP_2019_22794_38853.jpg

Concrete headwall on LS toe.
